Post-Earthquake Safety Evaluation of Buildings in Portoviejo, Manabí Province, following the M_w 7.8 Ecuador Earthquake of April 16, 2016

Abstract. This paper describes the post-earthquake safety assessments conducted by the European Union Civil Protection Team (EUCPT) following the M_w 7.8 Ecuador earthquake of April 16, 2016. The mission of the structural engineers within the EUCPT took place from April 22 to May 7, 2016. Several activities were performed: (i) rapid post-earthquake safety evaluations of buildings, (ii) demolition verification, (iii) safe road access, and (iv) detailed post-earthquake safety assessments of critical buildings. Despite the small number of structural experts, more than 1,000 buildings were inspected in Portoviejo and approximately 150 in Pedernales. Several lessons were identified during this mission, including the need of embedding local experts in foreign teams and the importance of having preparedness programs on post-earthquake assessment both for technicians and emergency managers. The efforts of the EUCPT benefitted largely from a Disaster Risk Reduction (DRR) pilot project which was underway at the time of the earthquake. While the project wa

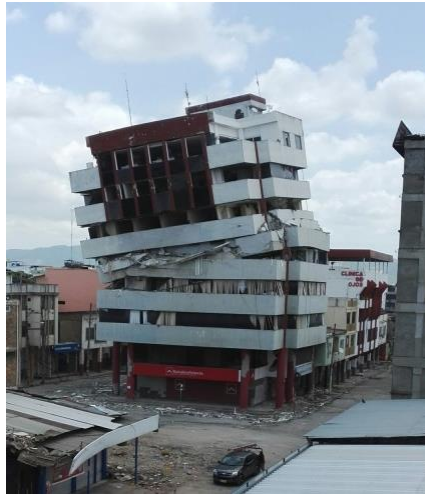
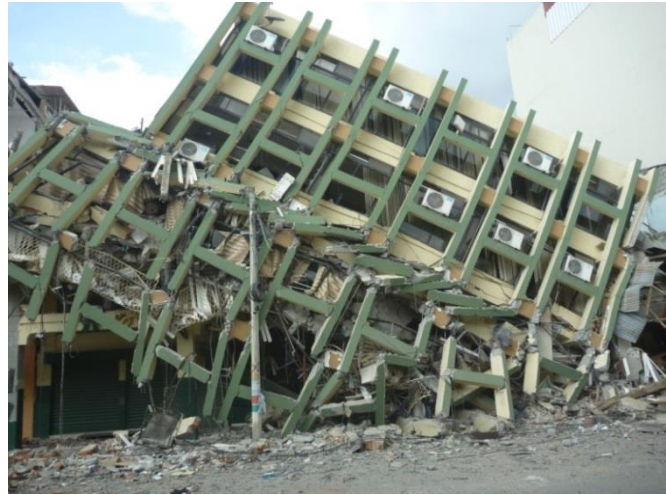
While modern building codes exist in Ecuador, Normas Ecuatorianas de Construcción [12], the observed damage suffered by many low and mid-rise RC buildings, such as those shown in Figure 6, suggests there was a lack of adequate seismic detailing and/or quality control which resulted in total or partial collapse of numerous buildings.

Figure 6. Severely damaged RC buildings in Portoviejo (a) and Manta (b).

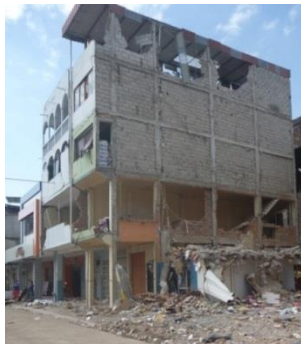
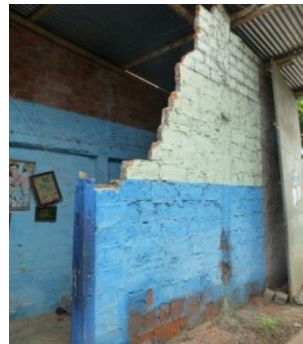
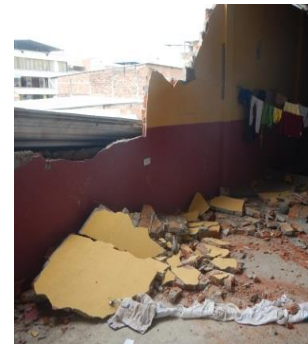
In many instances, RC buildings performed relatively well, but due to the presence of single layer unreinforced clay masonry used as infill walls, there was significant non-structural damage. In most instances, to save time and material costs, the walls were constructed by placing bricks laid on the long narrow side with the broad face of the brick exposed, leading to walls extremely susceptible to seismic damage. This type of wall was named “parado” (Figure 7).

Figure 7. Examples of the typical non-bearing slender masonry wall named “parado”.

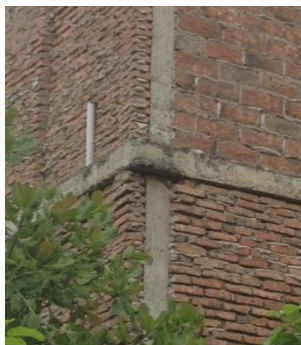
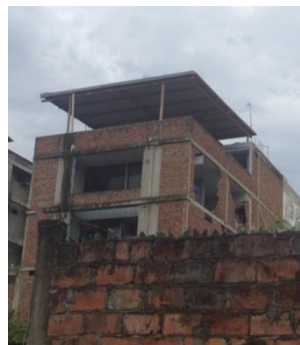
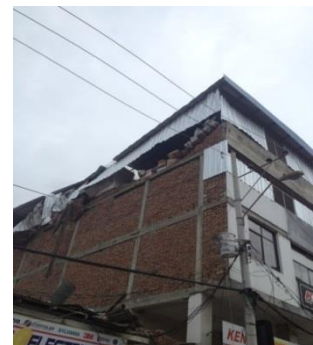
When the infill walls were built outside the structural frame, small RC columns, named “columnitas”, were placed between floors in order to confine or anchor the infill walls (Figure 8a). In some cases the bearing RC columns, larger than the “columnitas”, could be clearly identified (Figure 8b). In other cases, the presence of RC columns remained questionable (Figure 8c), where a “columnita” continues at upper storeys in the same position where a column is placed at ground level.

Figure 8. Examples of “columnitas.”

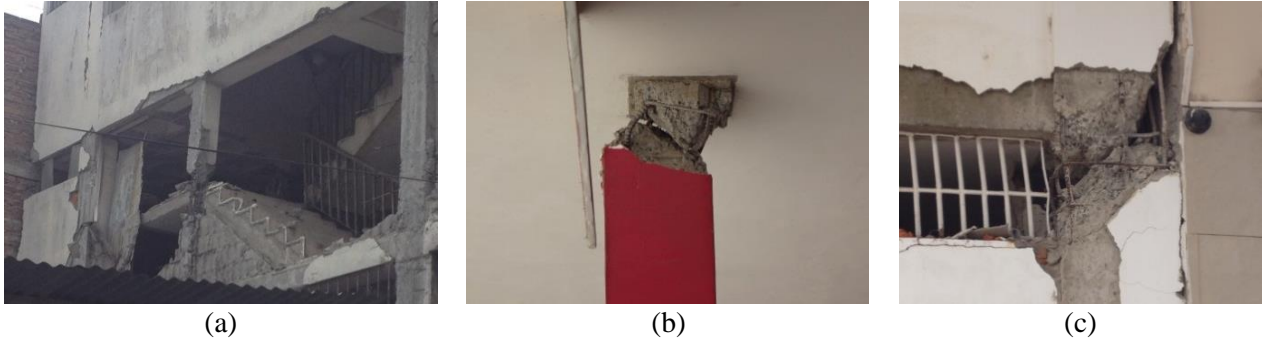
In RC buildings, brittle shear failures prevailed among other types of structural damage (Figure 9). In some cases, brittle failure was triggered by pounding effects with adjacent buildings or adverse interaction of the RC frame with the infill walls (Figure 10). Less frequently, a more ductile behaviour was observed with plastic hinge development at the base of ground floor columns (Figure 11). Few cases of soft storey mechanism were reported in upper storeys (Figure 12).

Figure 9. Brittle shear failures in RC buildings.

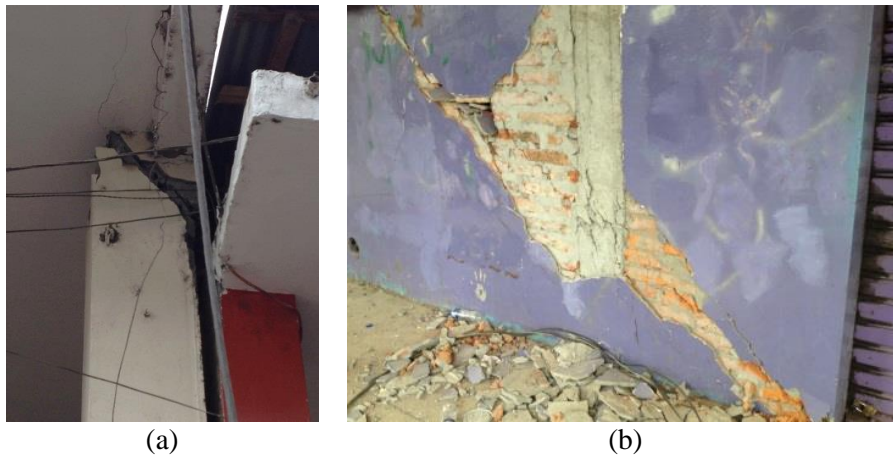
Figure 10. Brittle failures due to pounding (a) and interaction between RC frame and infill wall (b).

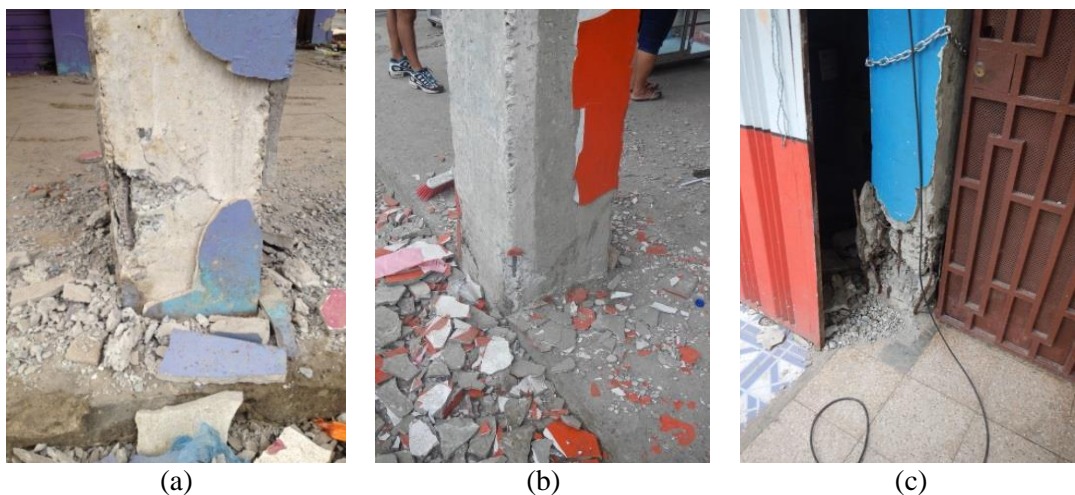
Figure 11. Plastic hinges at the base of RC columns.

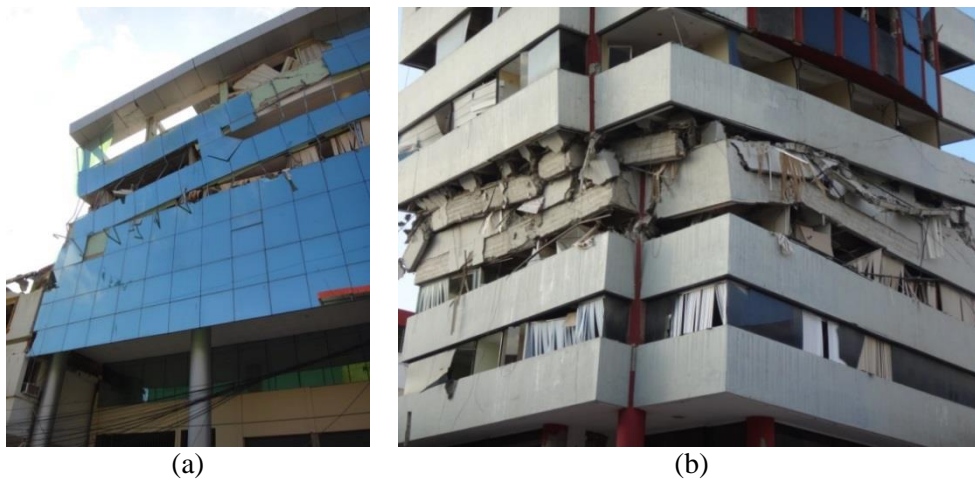
Figure 12. Soft storey mechanism at upper storeys.

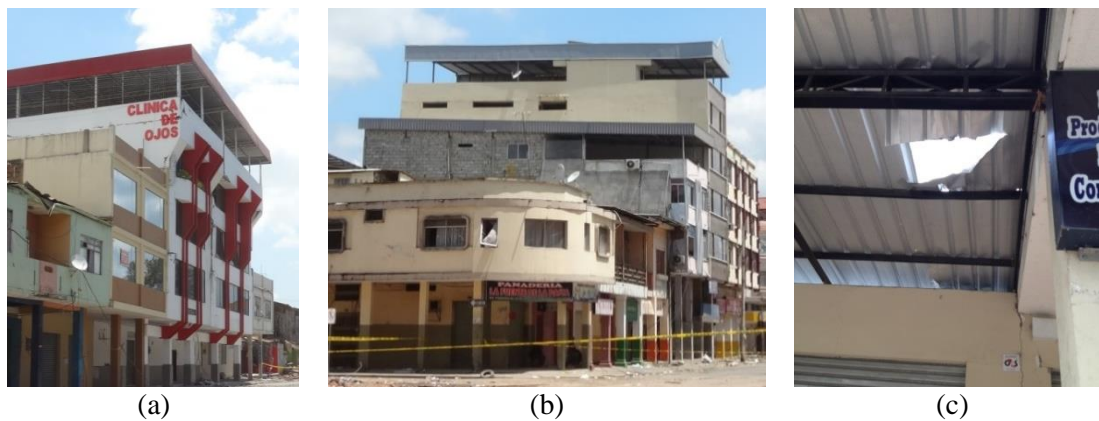
Light metallic roofs are very common in the area (Figure 13a, b). From a seismic performance perspective, the low weight of these roofs is beneficial. However, the lack of rigid floor at top of the building results in inadequate protection from debris or other falling objects from adjacent buildings (Figure 13c).

Figure 13. Light roofs on top of terraces.

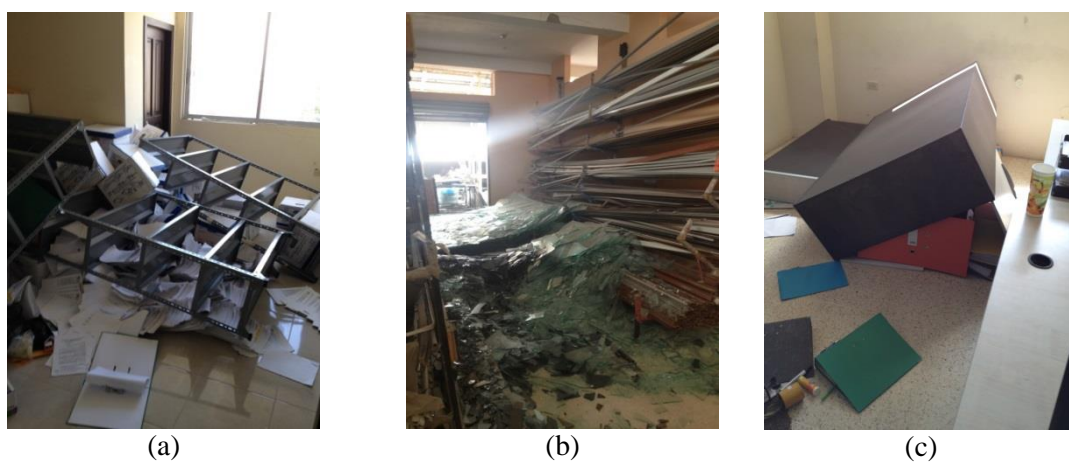
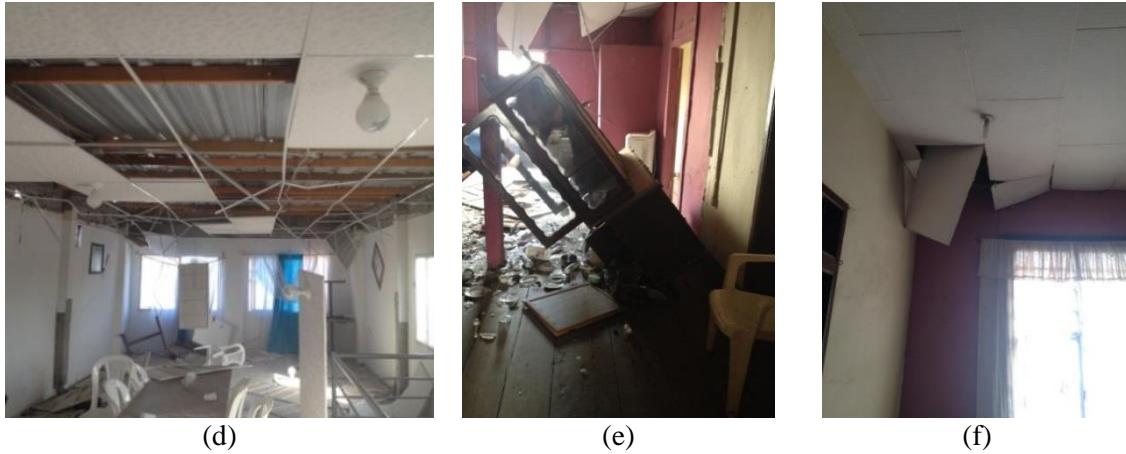
Damage to non-structural components was widespread due to the fact that they were not properly anchored to walls or roofs (Figure 14).

Figure 14. Damage to non-structural components and building contents.

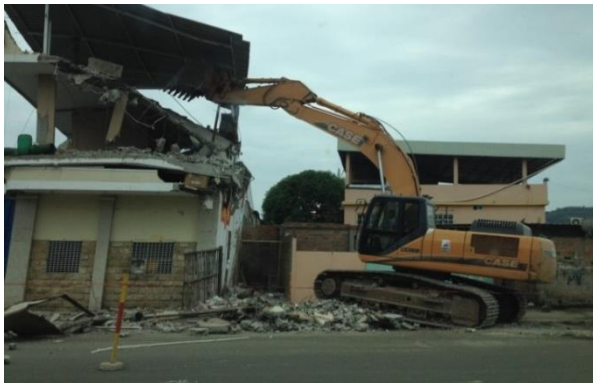
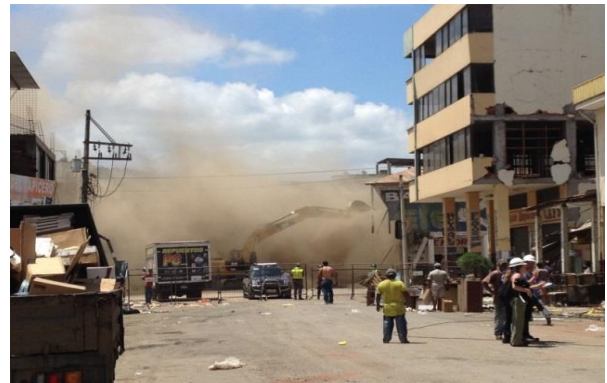
Figure 20. Demolition of a 3-storey building outside Zone Zero (a), and building collapse in Zone Zero during demolition (b).

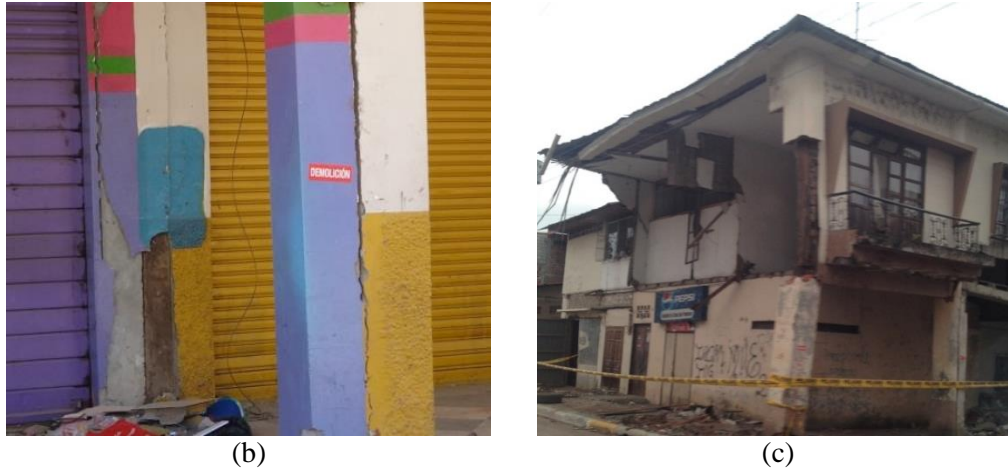
Figure 22. Placard for demolition, associated only with red tagged buildings (a) and two cases of buildings tagged for demolition (b), (c).

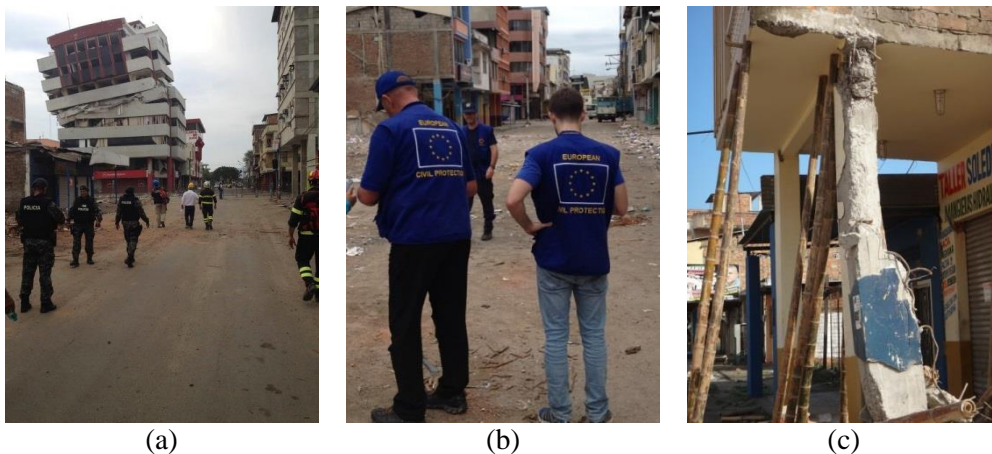
Figure 23. Cleared roads in Portoviejo Zone Zero (a) and (b), bamboo propping (c)

In order to enable safe road access, the streets had to be cleared from the debris from partially or totally collapsed buildings as seen in Figure 23a and 23b. In few instances, temporary shoring was required to stabilize damaged buildings, as shown in Figure 23c. Additionally, objects hanging from damaged buildings over the streets, as seen in Figure 24, had to be removed or stabilized. Lastly, some buildings had to be demolished due to the high risk of collapse.

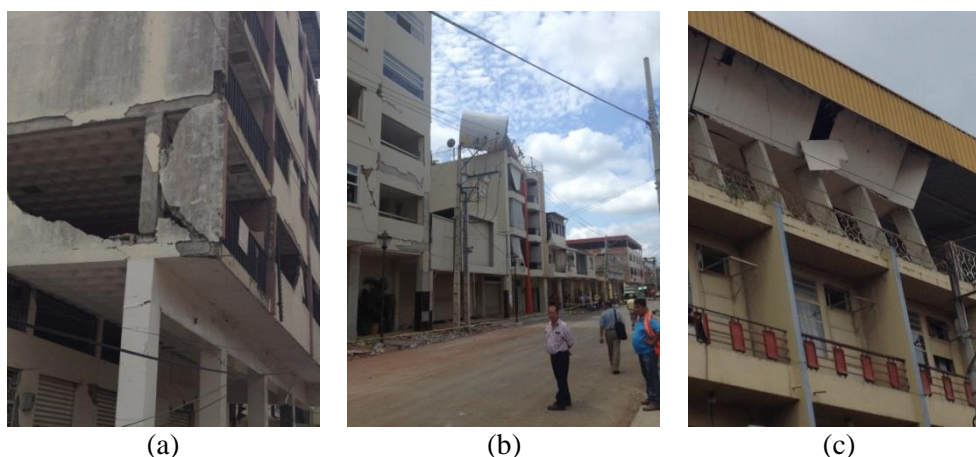
Figure 24. Examples of buildings with high risk of unstable elements falling on the street
