Post-Earthquake Safety Evaluation of Buildings in Portoviejo, Manabí Province, following the M_w 7.8 Ecuador Earthquake of April 16, 2016

Abstract. This paper describes the post-earthquake safety assessments conducted by the European Union Civil Protection Team (EUCPT) following the M_w 7.8 Ecuador earthquake of April 16, 2016. The mission of the structural engineers within the EUCPT took place from April 22 to May 7, 2016. Several activities were performed: (i) rapid post-earthquake safety evaluations of buildings, (ii) demolition verification, (iii) safe road access, and (iv) detailed post-earthquake safety assessments of critical buildings. Despite the small number of structural experts, more than 1,000 buildings were inspected in Portoviejo and approximately 150 in Pedernales. Several lessons were identified during this mission, including the need of embedding local experts in foreign teams and the importance of having preparedness programs on post-earthquake assessment both for technicians and emergency managers. The efforts of the EUCPT benefitted largely from a Disaster Risk Reduction (DRR) pilot project which was underway at the time of the earthquake. While the project wa

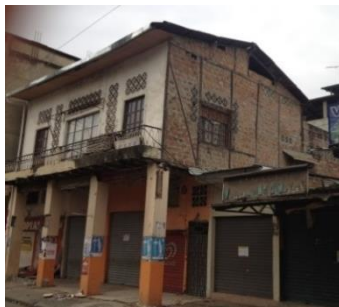
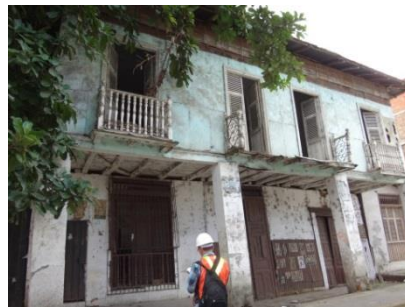
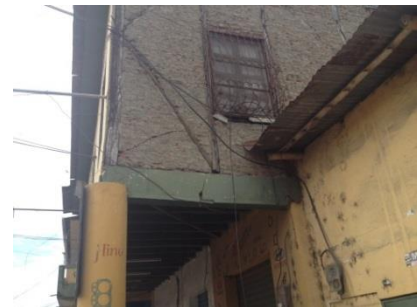
It was observed that poorly built structures were a significant factor in casualties and overall damage. Within Portoviejo, reinforced concrete (RC) is the main construction material, while wood is used in older buildings and there are still several buildings which use traditional construction materials like bamboo and clay. Traditional construction types are made with wood and masonry walls (see Figure 4) or wood and “quincha” (bamboo covered with mud) walls (see Figure 5). While many of these buildings were not engineered, in general, they performed relatively well due to their light weight and flexibility. Damage observations in these buildings were attributed to poor maintenance.

Figure 4. Wood and masonry buildings.

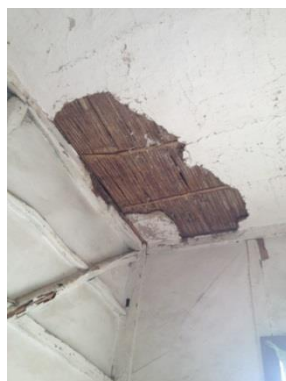
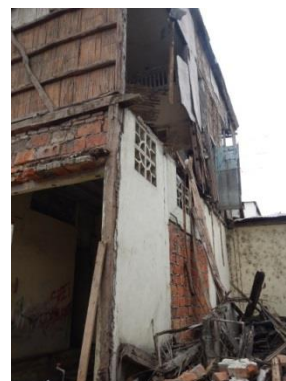
Figure 5. Wood and “quincha” buildings.

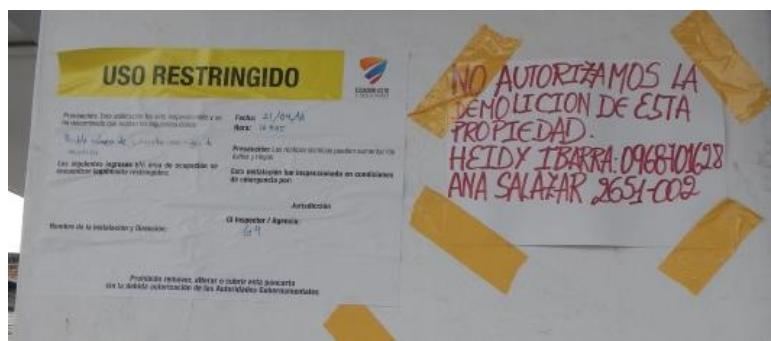
A large number of buildings had already been selected for demolition, particularly in the Zone Zero of Portoviejo, when the EUCPT arrived. Demolitions were often performed with inadequate vehicles and with limited concern for public safety (Figure 20a), which often resulted in the sudden collapse of the building (Figure 20b). Demolition work was initiated so soon after the earthquake due to the immediate availability of vehicles (up to 80) and demolition equipment provided by Ministry of Transport and Public Works. As a result, many buildings were demolished in the absence of a structured procedure. Citizens feared their houses would be demolished without their approval or removal of their goods. These concerns resulted in signs posted on buildings by owners, as seen in Figure 21, prohibiting demolition.

Figure 21. Yellow tagged building and owner statement in response: “We do not authorize the demolition of this property.”
